BRE: Post Installation Performance of Cavity and External Wall Insulation

Cavity Wall Insulation

External Wall Insulation

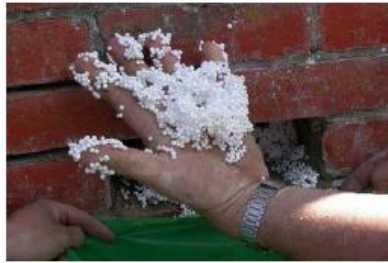
Figure 3: Example of saturated insulation

- Wet insulation extracted
- Clumping
- Saturated walls

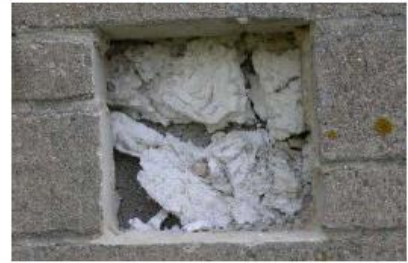
Figure 4: Example of saturated insulation

Other properties visited during the research were showing signs of issues associated with condensation and moisture ingress, which could be the result of saturation and the subsequent failure of the CWI.

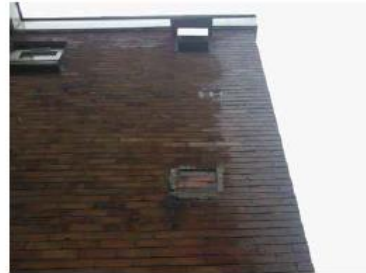
Other issues were identified where rainwater has overblown the roof and has saturated elements of the wall as shown in Figures 13 & 14 below.

Figure 13: Wall staining from water blown off the roof

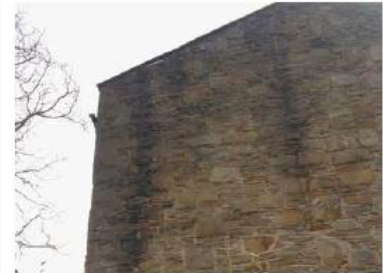
Figure 14: Staining from roof water run off

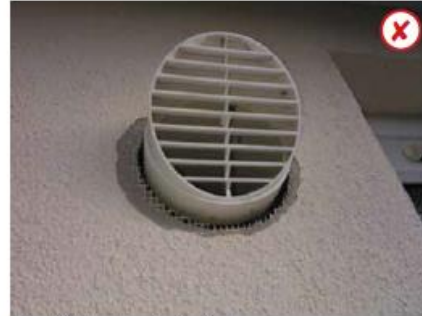
Figure 34: Unsealed extract fan in a bungalow

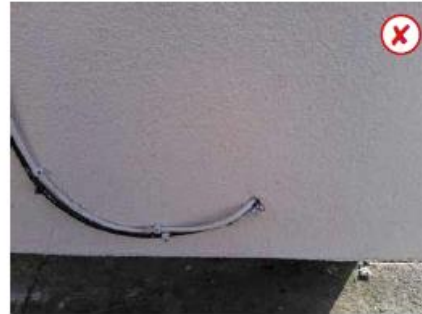
Figure 36: Unsealed wire penetration

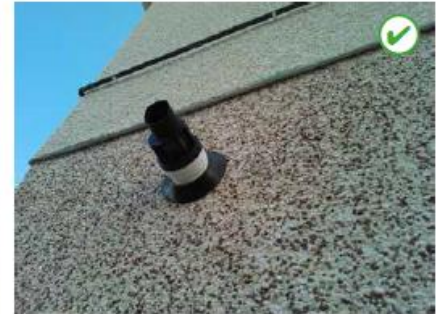
Figure 37: sealed penetration (good practice)

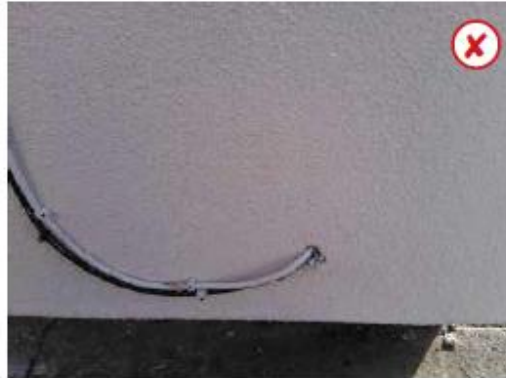
Figure 38 - cable clipped

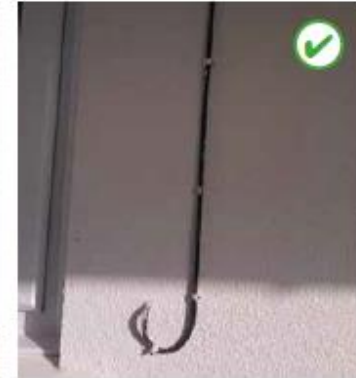
Figure 39 - cable clipped (good practice)

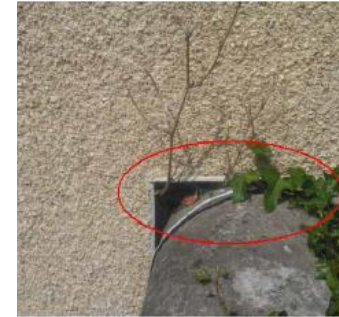
Figure 48: Plant growth allowed by poor detailing

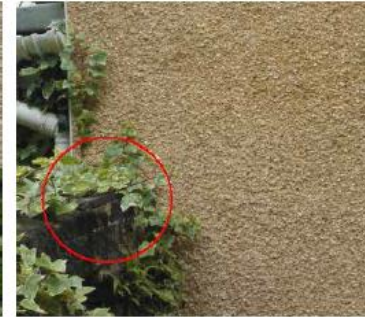
Figure 49: Close proximity of plant requiring pruning

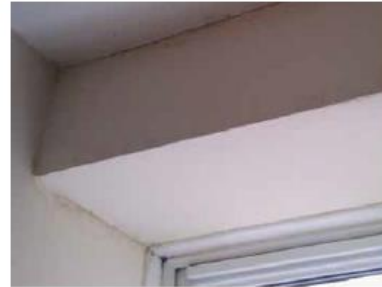
Figure 50: Damp in the kitchen

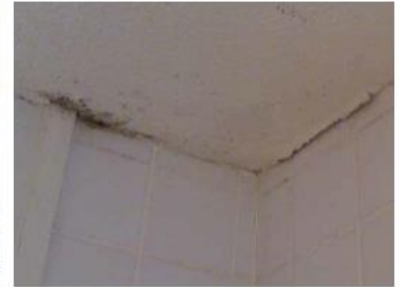
Figure 51: Damp in the bathroom

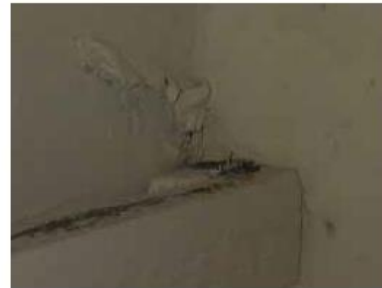
Figure 52: Damp in the wardrobe

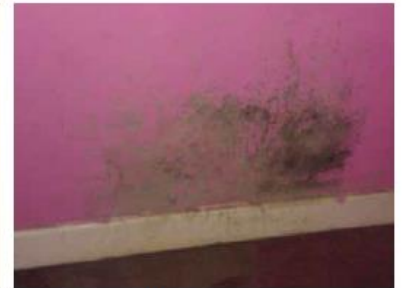
- Ventilation never assessed
- Mould growth after short periods of time, indicating systemic weaknesses in process
- Part F requirements for make it no worse ?

Figure 53: Damp behind a bed, removed for inspection
