BRE: Post Installation Performance of Cavity and External Wall Insulation

Colin King

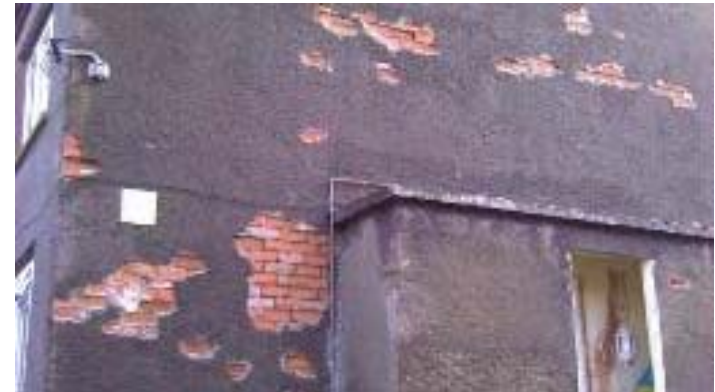
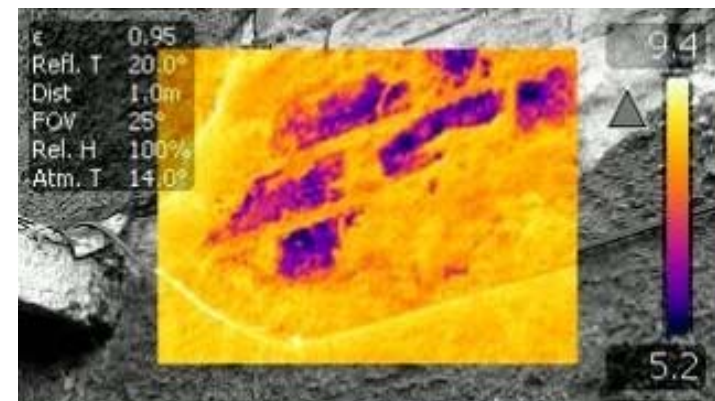
- Clusters of buildings with issues
- A range of reasons for non performance
- Narrow cavities <50mm outside of testing range

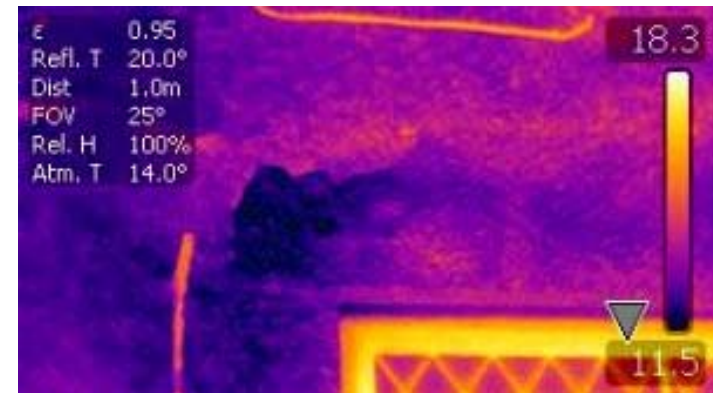
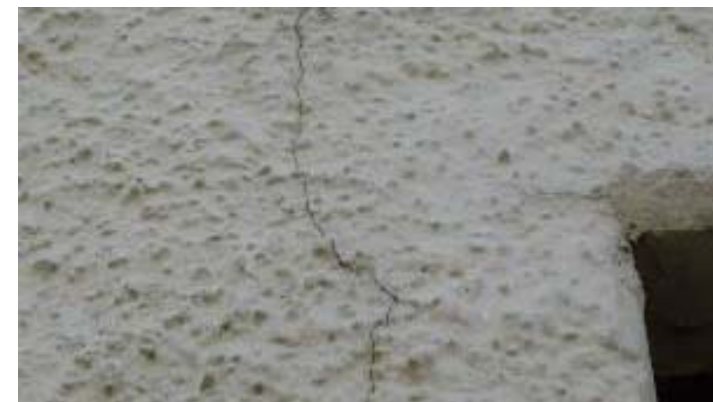
- No protection from local features
- Lack of maintenance and repair

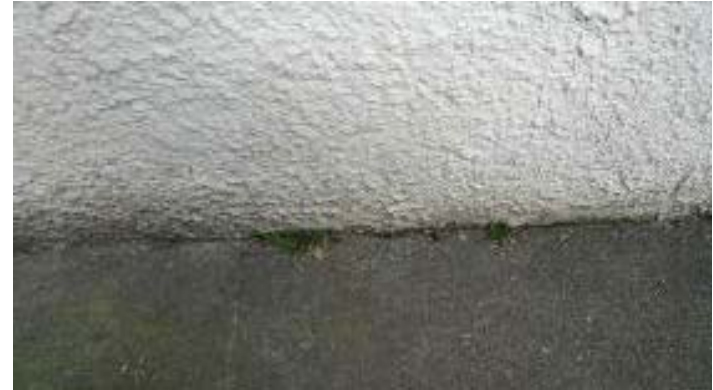
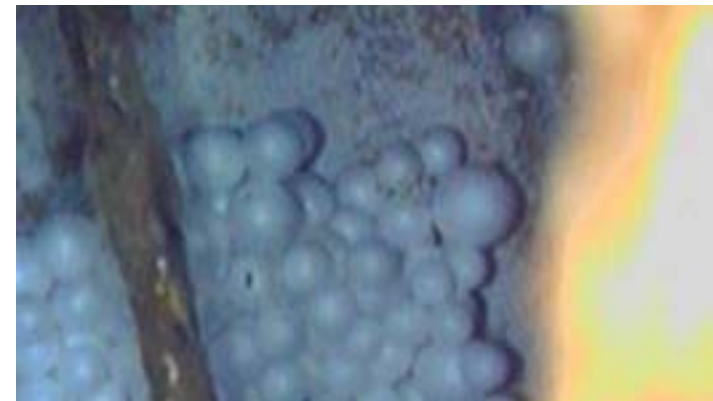
- Blocked cavities or partially filled
- Installations, outside certification
- No reference to BBA

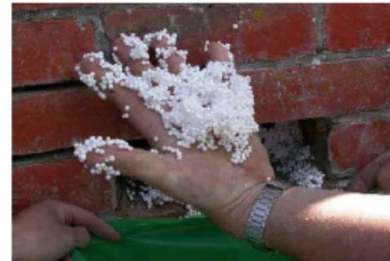
Figure 3: Example of saturated insulation

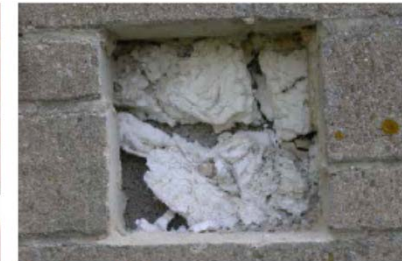
Other properties visited during the research were showing signs of issues associated with condensation and moisture ingress, which could be the result of saturation and the subsequent failure of the CWI.

Figure 4: Example of saturated insulation

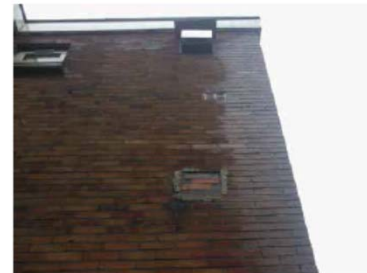
Other issues were identified where rainwater has overblown the roof and has saturated elements of the wall as shown in Figures 13 & 14 below.

Figure 13: Wall staining from water blown off the roof

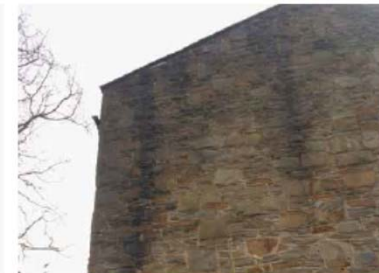
Figure 14: Staining from roof water run off

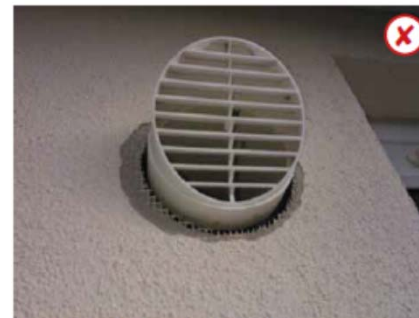
Figure 34: Unsealed extract fan in a bungalow

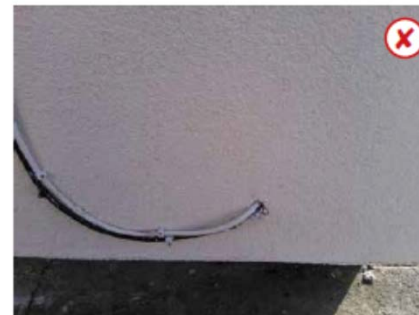
Figure 36: Unsealed wire penetration

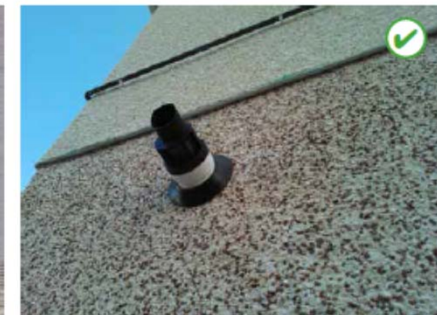
Figure 37: sealed penetration (good practice)

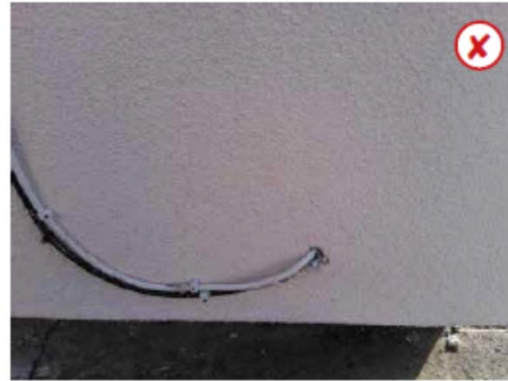
Figure 38 - cable clipped

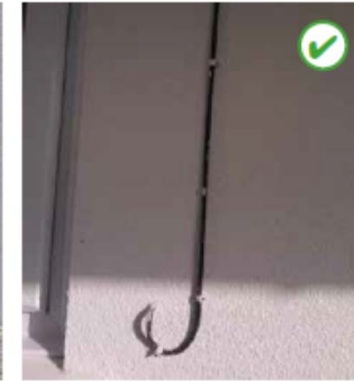
Figure 39 - cable clipped (good practice)

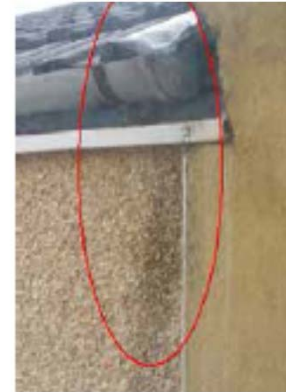
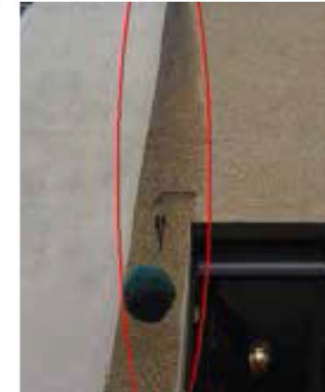
- Poor design or no design
- Poor workmanship
- Moisture ingress less than 4 months after installation

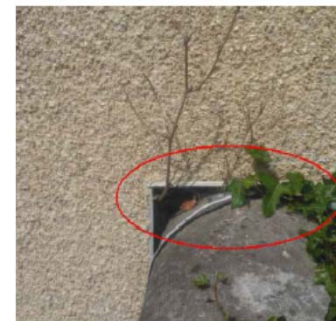
Figure 48: Plant growth allowed by poor detailing

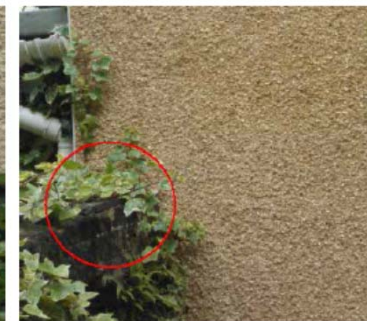
Figure 49: Close proximity of plant requiring pruning

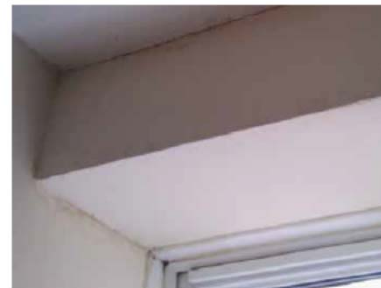
Figure 50: Damp in the kitchen

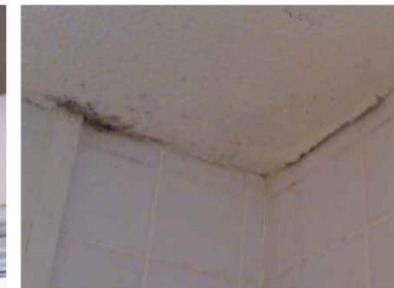
Figure 51: Damp in the bathroom

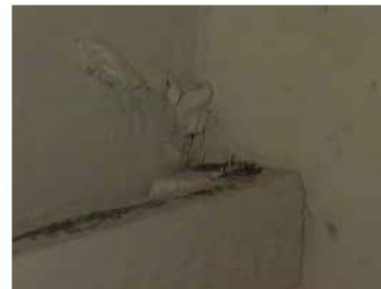
Figure 52: Damp in the wardrobe

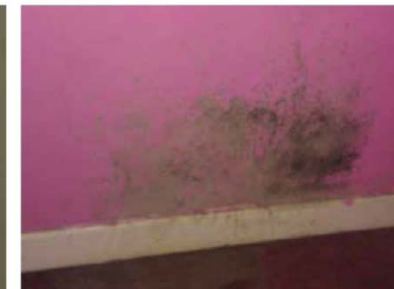
Figure 53: Damp behind a bed, removed for inspection
