# Evaluation of Bin Fill Level Sensor Trial

Report for Enevo in partnership with  
London Borough of Islington Council

This report has been  
prepared by Paddy Knowles  
in July 2016

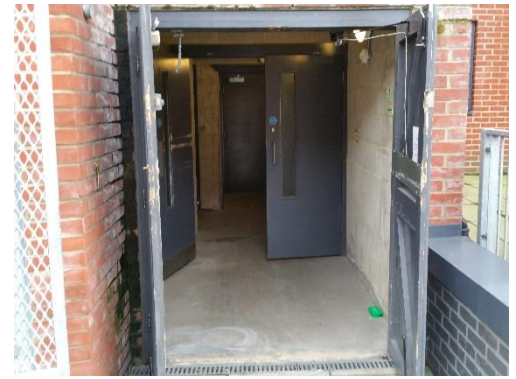
(Fig 2) Entrance to underground storage area

3.1 Collection round ER2, is tasked with collecting a number of above ground communal bins containing mixed dry recyclable materials which are located at various property locations around the Islington area. The round is made up of mostly 1100 litre Euro containers which have, as part of the project been fitted with fill level sensors. There are also a number of locations that use communal bins that are unable to use sensors, particularly those located in underground storage areas (fig 2).

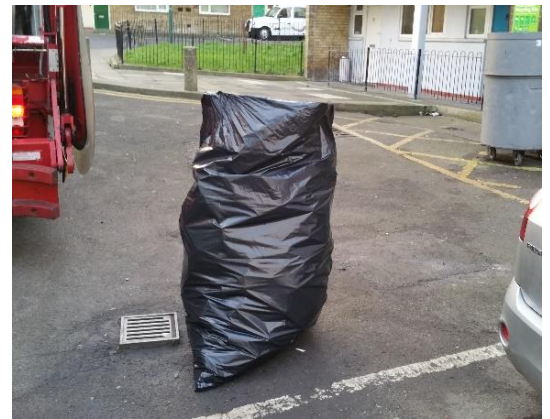
(Fig 3) Estate Bag

3.3 With the exception of the 1100 bins used in the underground storage areas, many cold call locations use either 240 litre and 360 wheeled bins, reusable estate bags or clear sacks. The reusable estate bags are large black sacks into which waste is placed for movement to the vehicle which are then manually emptied into the wagon (Fig 3).

3.4 Estate bags are a large durable black sack into which the team would drag from location to location, collecting the material and dragging it to the vehicle. The vehicle lifts are then isolated and the recyclables are then manually emptied into the wagon and the sack reused for the next location.

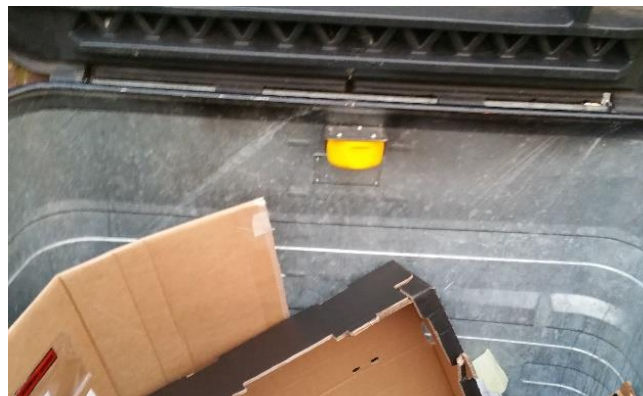
(Fig 5) Possible cause of false sensor reading

4.43 Throughout the day the vehicle visited a number of sites where the system showed bins as full or ready for collection. However, when we arrived on site, there were bins which were not yet full. These were bins that may have registered as full due to the fact they had a large cardboard box or some other item in them that hadn't been broken down by the resident, giving a false reading (Fig 5).

4.44 This happened at a number of sites and although impossible to completely eradicate, did raise a potential miss-use and education issue for the authority.

- It is recommended that an information and education programme is developed and implemented with the aim of improving participation in the service and to educate residents in both the reduction in contamination and encouraging residents to break down boxes where required.

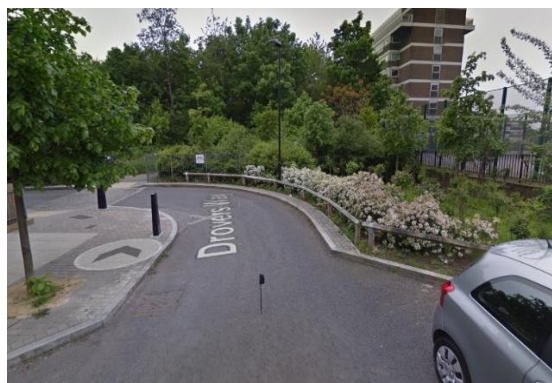
(Fig 6) One of the tight street corners navigated by the crew  
Drovers Way

4.47 Among the other issues observed which have the potential to make collections difficult are congested traffic conditions and the vehicle having to navigate very narrow streets containing double parked cars (Fig 6).

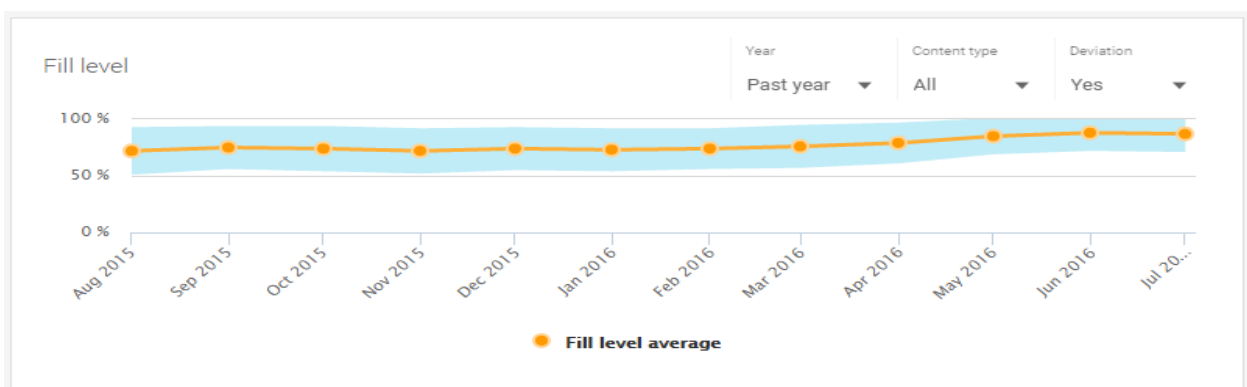
**Fig 7.**

- 5.6 Fig 7 below is taken from the Overview page of the system and clearly indicates that since the system was set up in July 2015 with the exception of July itself, the average fill level recorded had remained constant at between 72% and 73%. Since the smart route system went live in January 2016 the average fill level had risen consistently month on month, from an average of 73% in January 2016 to an average of 87% in July 2016.

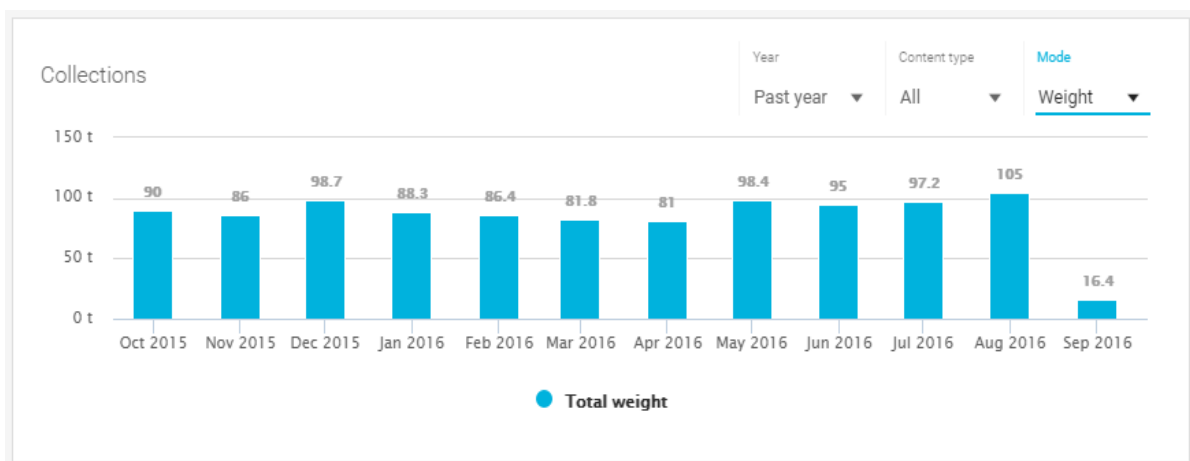
**Fig 8.**

- 5.7 Interestingly, the system also shows, as can be seen in Fig 8 below, the weight collected in KGs in the initial stages of 2015 growing consistently to a peak in December which to a degree could be seen as a seasonal peak due to the Christmas festivities. At the point that the system went live in January there then appears to be a period where the tonnages consistently reduce up to May when there is another peak.

- 5.8 This peak could be contributed to an event such as the European football championships which began in May and there was also a period of good weather which could have resulted in additional recycling from BBQs etc.

- 5.9 The reduction in weight over the months January to April equated to a reduction of by 8.2% with weights being between 80 and 90 tonnes per month. Only time and further monitoring will tell if the peaks recorded are one off event or seasonal peaks. However. Looking at the data for preceding months up to September 2016 shows tonnages and volumes remaining consistently high with a great peak to 105 tonnes in September.

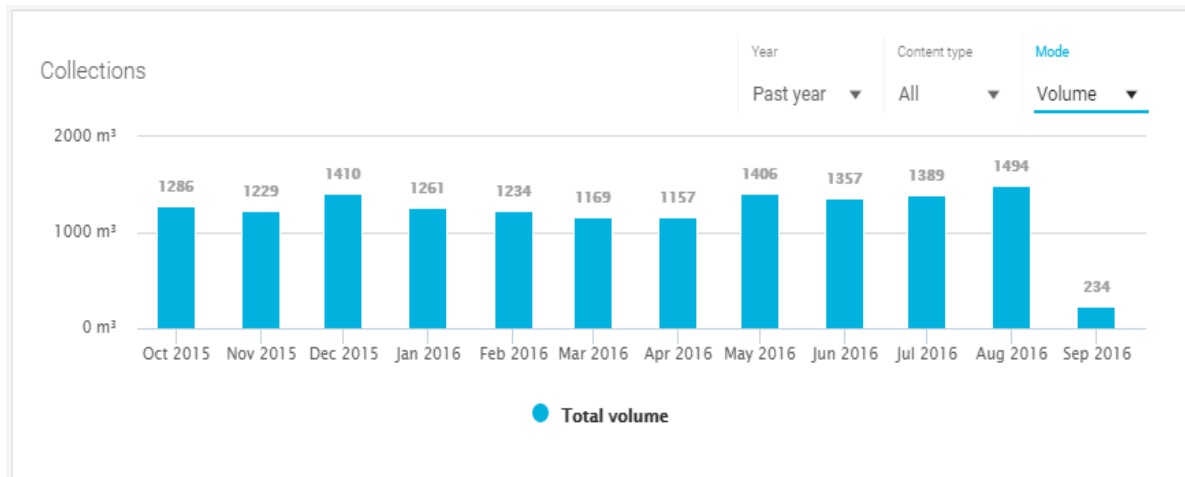
**Fig 9.**

- 5.10 Looking at Fig 9 below, it shows a reasonably consistent picture with that of the tonnage in Fig 6 above. The same peaks can be observed appearing in the data and since the implementation of the system it can be seen that the volumes of waste collected again consistently reducing over the first 4 months of 2016, again by 8.2% between 1261 m<sup>3</sup> and 1157 m<sup>3</sup> with May's figure peaking as in the tonnage data.
- 5.11 As expected, volumes and tonnages data appear to be directly correlated and follow the same trend. It also gives the opportunity to observe potentially where peaks in demand will arise in the future.

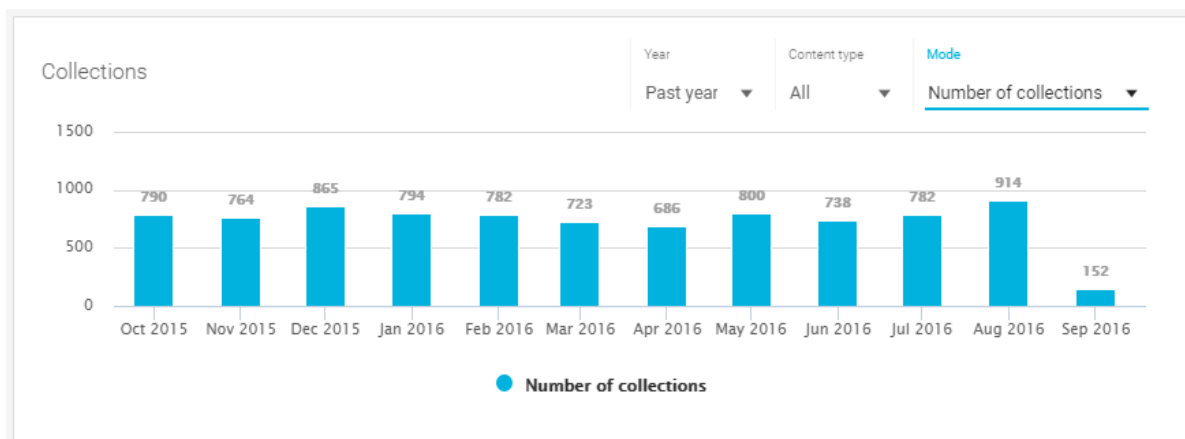
**Fig 10.**

5.12 In contrast, Fig 10 below shows that following the implementation of the system going live in January there is again a consistent month on month reduction in the number of collections made but equating to a considerably higher degree (13.6%). This increased reduction in the number of collections is greater than the reduction in volume and tonnage of 8.2%, and could indicate that the team is making less collections overall with only a minimal effect of volume and tonnage collected.

5.13 Although not definitive, this is possibly the first indication that the system may be having a positive effect on the service provision and if the current issues regarding compliance with the given route could be resolved, these efficiencies might be further enhanced.

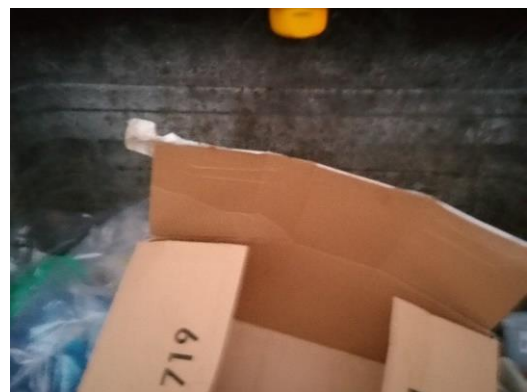
(Fig 11) Possible cause of false sensor reading

- 6.15 There were also, as on the first visit, a number of sites where the system must have been showing bins as full or ready for collection to have included them on the route, but when the crew arrived the bins were not yet full. However, it should be noted that the number of occasions this happened during the second site visit was significantly lower (20%) than on the first (Fig 5), and again were as a result of the same issue, boxes not being broken down by the resident, giving a false reading (Fig 11).

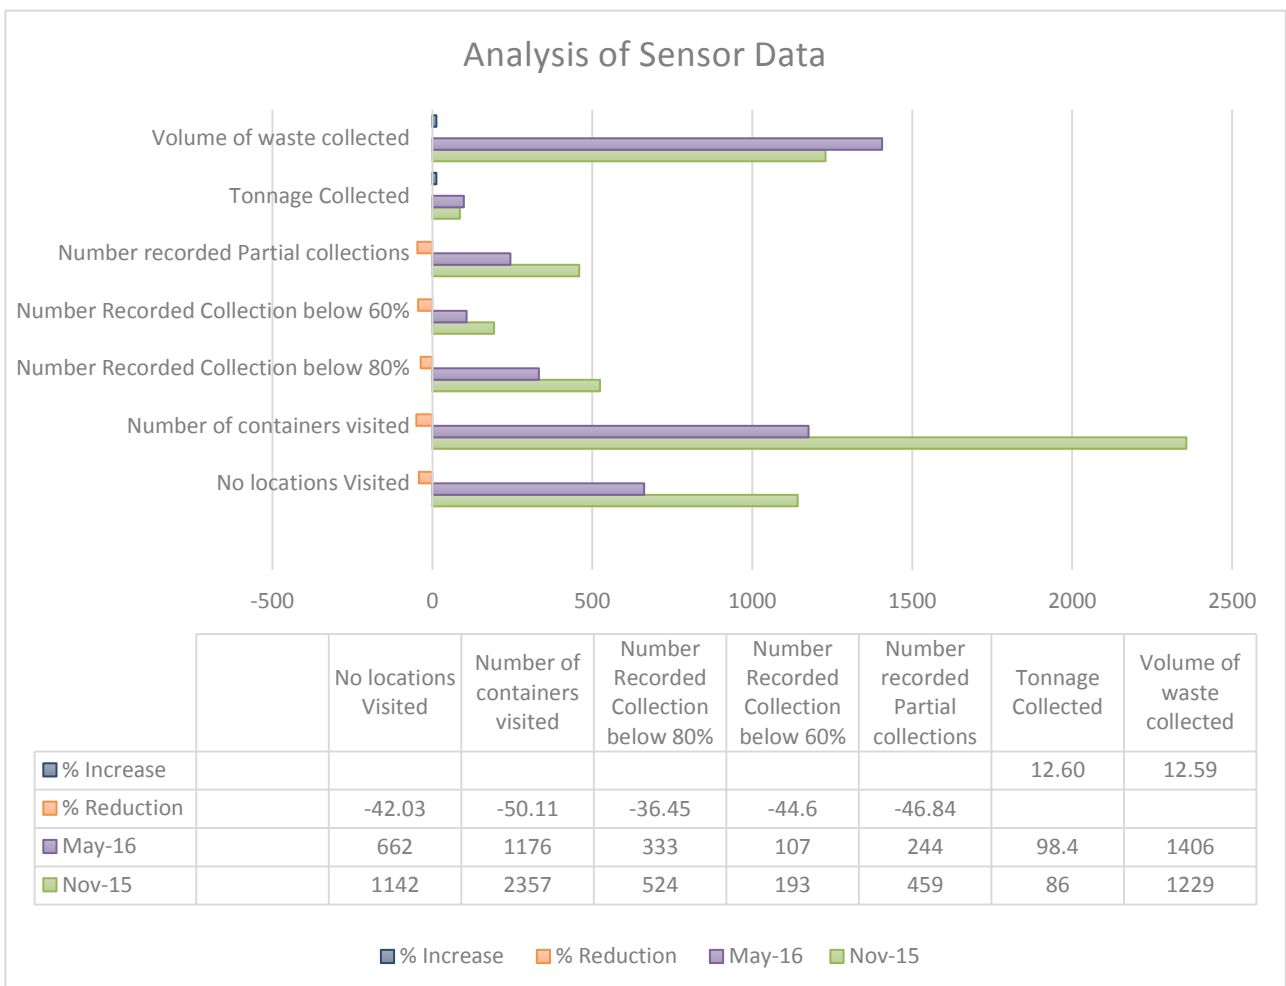
**Fig 12**

- 7.2 The analysis of the pre and post implementation data periods show that there have been significant decreases (44.28%) in the number of locations visited, a (52.02%) decrease in the number of containers visited and a (38.9%) reduction in the number of bins visited recorded as below the initial 80% level and a (44.60%) reduction in the number of bins recorded a below the reset 60% fill level, whilst the tonnage of waste collected has increased slightly.
- 7.3 It is also interesting to note that as expected, the volume of waste collected over the two data periods has increased to a similar extent as the tonnage by (12%). Although this is not generally reflected in the 5 months between the two data periods as can be seen in figure 12 below.
- 7.4 Fig 12 below pictorially represents the results of the analysis of the collection data for the pre and post implementation periods.

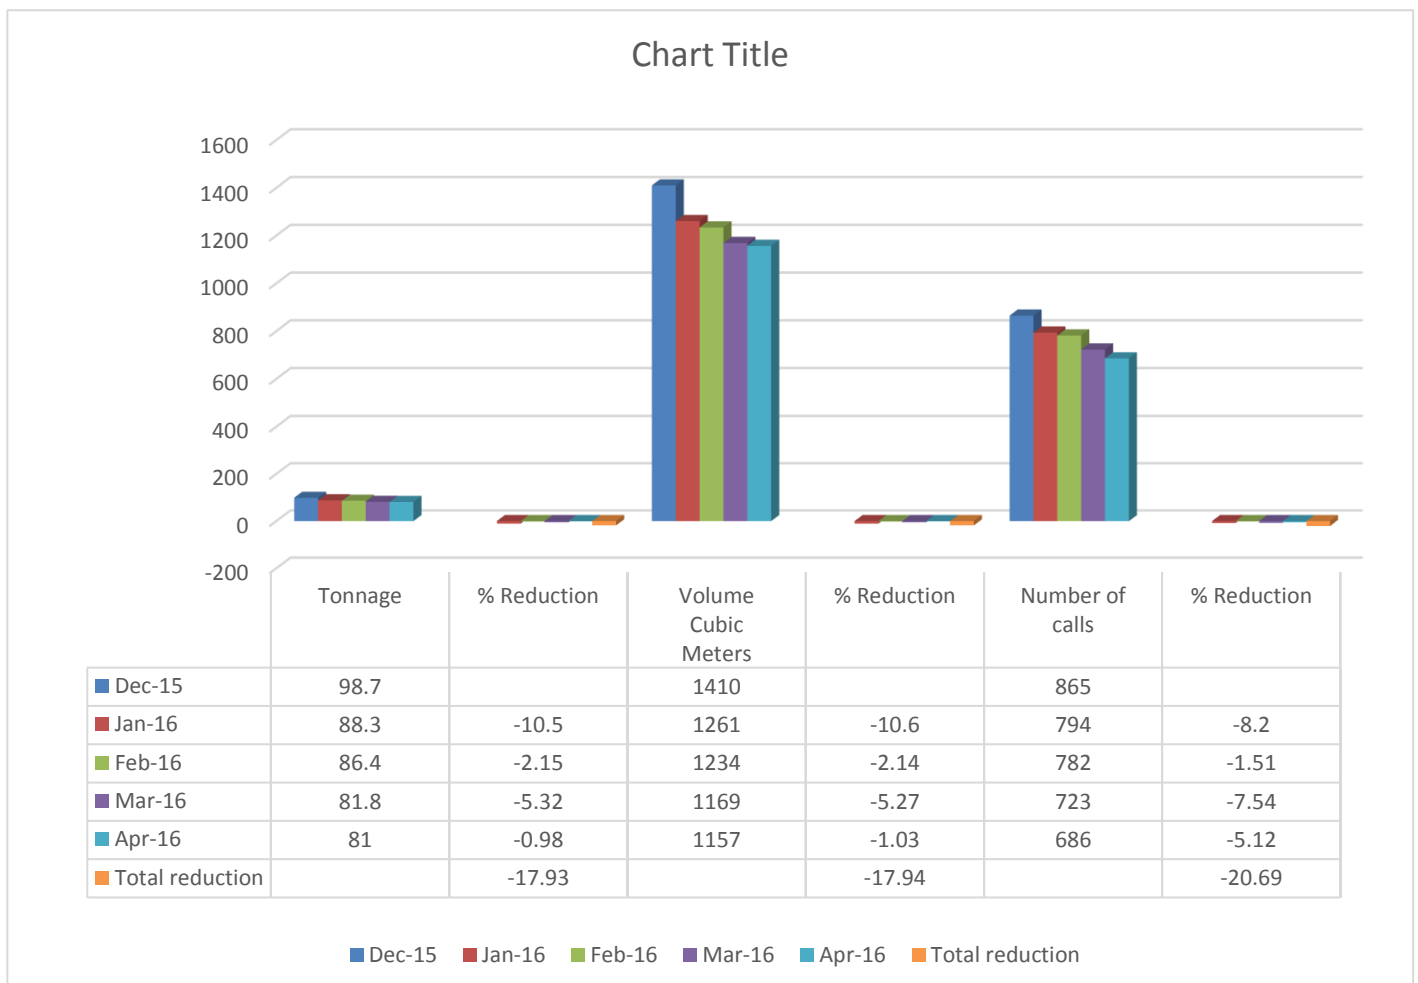
**Fig 13**

7.6 Figure 13 below is an analysis of the data from the overview page, for the 5 months between the pre and post implementation data set and shows a consistent reduction in tonnage collected, volumes of waste collected and number of calls made of between 17% and 21% with tonnage and volume following a similar trend, however it should be recognised that tonnage and volumes of waste did not reduce as steeply as the number of locations visited.

7.7 There are a number of reasons that could account for this drop off, seasonal variations, the crew getting used to the new system, changes in manning of the crew when the driver or other full time team members are off sick or on leave, and possibly the crew not following the smart route to its full effect. It is impossible to justify any one reason at this time.

- Further analysis is therefore recommended to establish if the drop off identified in the first 4 months of 2016 is as a result of the crew getting

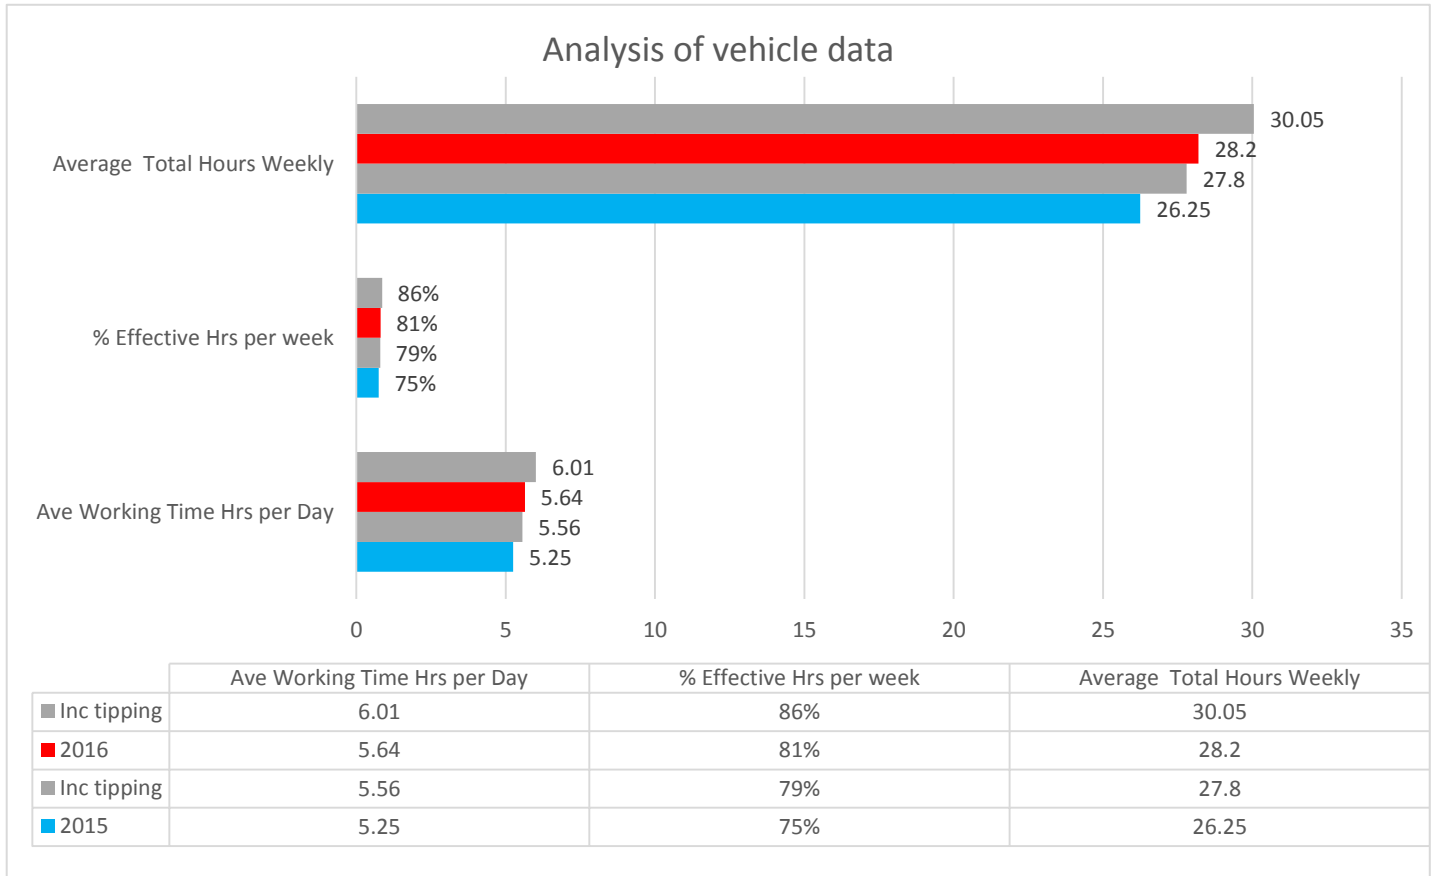
**Fig 14**

7.11 Figure 14 below, shows the effective working hours of the crew and vehicle. It should be noted that the hours indicated for the individual months 2015 and 2016 show the time the vehicle starts and finishes collections at the depot and the time including tipping the vehicle is shown separately. However, in the case of the effective hours worked by the loaders in as in many cases they leave the wagon before the vehicle returns to the depot, the effective working hours for the loaders will be much less in every case.

7.13 It is unknown at this time if the effectiveness of the wagon would be further improved by the crew following the smart route, as it is issued to them, as so far throughout the trial they have failed to follow it.

- It is recommended that the effective working time should be further investigated to ensure that all the allowed breaks and allowances are being accounted for. This might potentially be achieved through some work study / Method study work to update and re-establish the allowances allocated through the work carried out by Eunomia some time ago.

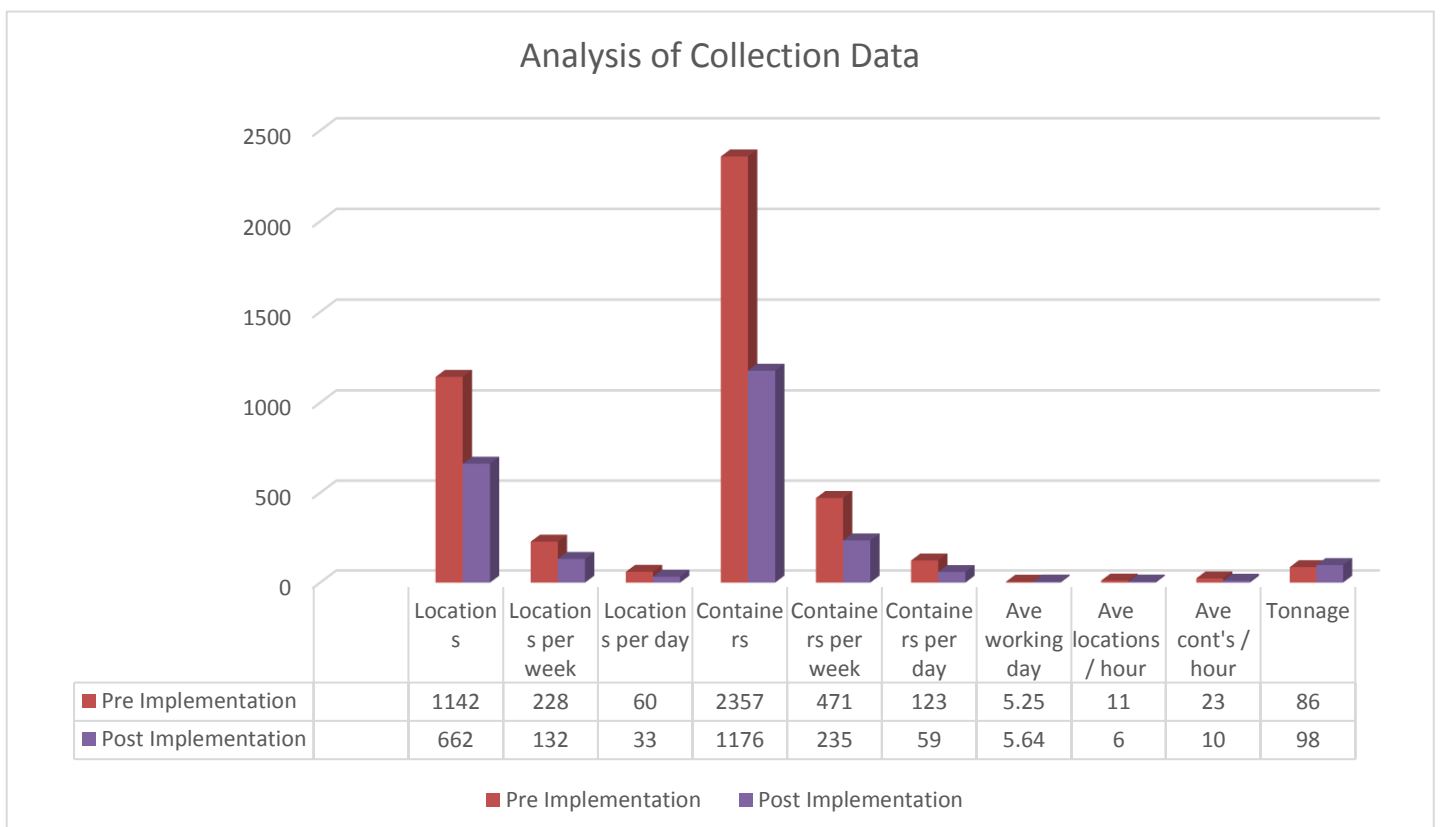
**Fig 15**

- 7.14 Figure 15 below shows the average collection data for the number of collections and containers over the two periods and shows the effectiveness the routing system has had on collections with the crew visiting less locations and containers per week / day whilst tonnage and volume has increased.

- 7.15 During the four weeks of the pre-implementation period analysed, the crew collected from 1142 locations, an average of 228 locations per week or an average of 60 individual locations per day. In terms of individual containers during this period, the crew collected on average 2,357 containers, an average of 471 collections per week or 123 collections per day.

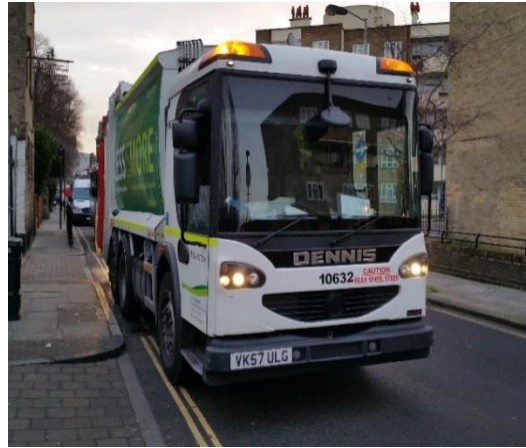
(Fig 16) Vehicle ER2 (VK57ULG)

8.2 The vehicle identified as normally being used by round ER2 (Fig 16) is an 8 years old Dennis refuse freighter, which in terms of operational refuse vehicles is quite old and possibly coming towards the end of its useful life as a front line vehicle, therefore it may not be as efficient in terms of fuel usage as a new or newer vehicle.

- It is recommended that as part of the review recommended in 9.3.4 above, the potential for an urgent programme of vehicle replacement be considered to enable the service to take further advantage of the efficiencies being identified through the use of the sensors.
- It is further recommended that investigations be undertaken into the viable use of sensors on the domestic refuse collection rounds that use communal bins with a view to potentially removing the need for scheduled collections of bins that are potentially not yet full.
